Mynydd Llanhilleth Wind Farm

Phase 1 Geoenvironmental Desk Study

November 2022

Doc Ref. 807095-WOOD-RP-OG-0002_P01

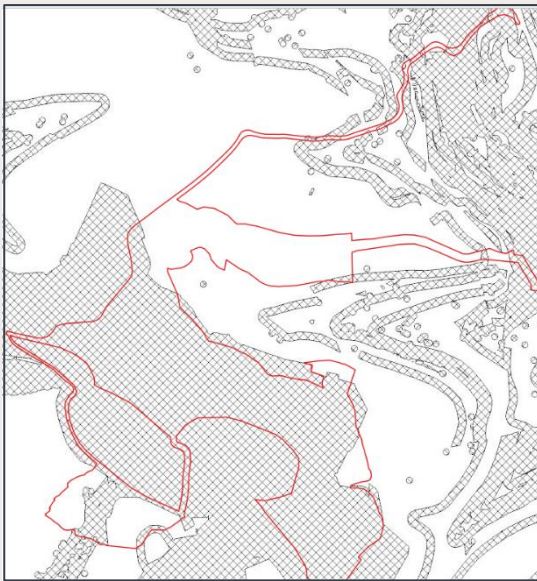
Development High Risk Areas (Source: Coal Authority WMS layer)

The majority of the Wind Farm site is classified as a Development High Risk Area on the Coal Authority Interactive Viewer; this is consistent with the mapped area of surface working (historic/current) and an area of

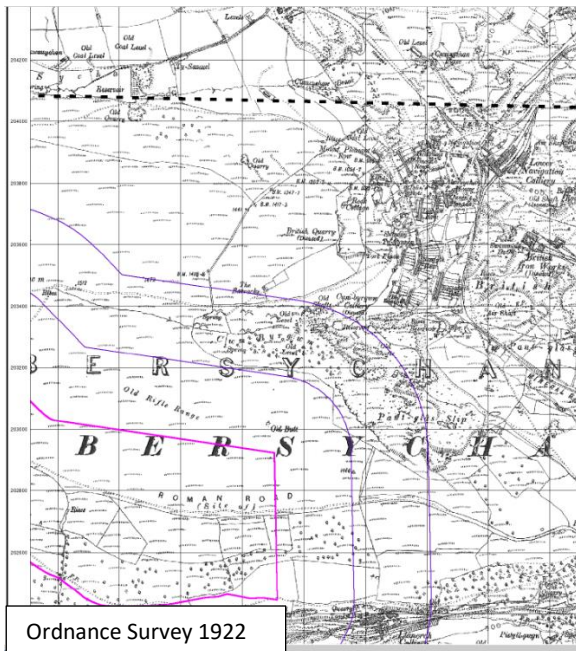
Access Road

1886: The western section of the alignment is shown to be a track, which runs through rough grazing on the northern edge of Cwm Byrgwm. Several collieries and shafts are shown towards the base of the valley slope within Cwm Byrgwm. The eastern half of the route passes through an industrialised area, with a track/roadway shown to have been present intermittently. British Quarry and British Iron Works are shown in close proximity to the route, which crosses and runs adjacent to several areas of spoil heaps to the north of the area identified as British. Two reservoirs associated with British Iron Works were located immediately to the south of the alignment.

1902: No changes noted over western end of route. In the eastern half of the route, British Quarry is now shown to be disused, and the two reservoirs associated with British Iron Works are no longer shown, presumed to have been infilled. A mineral railway runs adjacent to and crosses the route at its eastern end.
